# KAY STREET BRIDGE WIDENING AND REFURBISHMENT BURY

Reconstruction & widening of a partially collapsed double arch masonry road bridge over the River Irwell following a major flooding event.

CLIENT  
**BURY MBC**

VALUE  
**£1.4M**

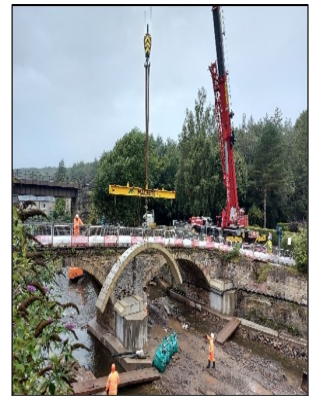
On restarting works we again accessed the river via a temporary causeway and undertook strengthening works around the central pier and the abutments on either side of the river including; temporary dams/pumping; cased and augured RC piles to 21m depth (see photo right); RC pile cap; mass concrete scour protection beams to abutments/retaining walls adjacent to the structure. We then undertook the original scope for widening and restoring the bridge.
